## **Twenty-four Mile Creek Stream and Riparian Assessment**

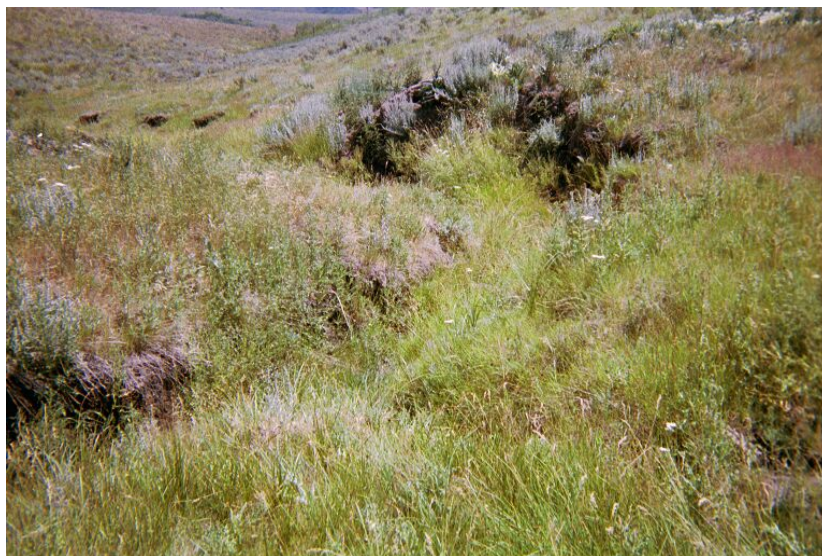
Reach	TFMC8
Length (ft)	3,213
Elevation (ft)	6,112
Stream Order	2 <sup>nd</sup>
Slope (%)	1.1
Sinuosity	1.1
Drainage Area (miles <sup>2</sup> )	8
SVAP	Poor
PFC	FAR
SECI	Moderate
Erosion (t/yr)	65

This photo of TFMC8 was taken looking upstream. There was a series of old breached beaver dams that the stream has downcut through.

Ten to twelve breached inactive beaver dams with headcuts comprised the reach. The channel was incised. Riparian vegetation extended at least one active channel width. Streambanks were moderately unstable. Sedge and rushes were present however woody species were non-existent. Less than 20% of the stream was shaded. Evidence of livestock access to the riparian area was noted. The reach had infrequent flooding events above bankfull, vertical instability, insufficient vegetative cover to protect streambanks, inadequate sources of coarse/large woody material and insufficient soil moisture characteristics. The reach was found to have erosion and cracking present on streambanks. Predominantly perennial/rock covered streambanks with moderate vegetative overhang. U-shaped channel with vertical banks about 2 feet high. Channel bottom in gravels and cobbles with numerous headcuts and evidence of recent deposition.

Streambanks were moderately unstable. Sedge and rushes were present however woody species were non-existent. Less than 20% of the stream was shaded. Evidence of livestock access to the riparian area was noted. The reach had infrequent flooding events above bankfull, vertical instability, insufficient vegetative cover to protect streambanks, inadequate sources of coarse/large woody material and insufficient soil moisture characteristics. The reach was found to have erosion and cracking present on streambanks. Predominantly perennial/rock covered streambanks with moderate vegetative overhang. U-shaped channel with vertical banks about 2 feet high. Channel bottom in gravels and cobbles with numerous headcuts and evidence of recent deposition.

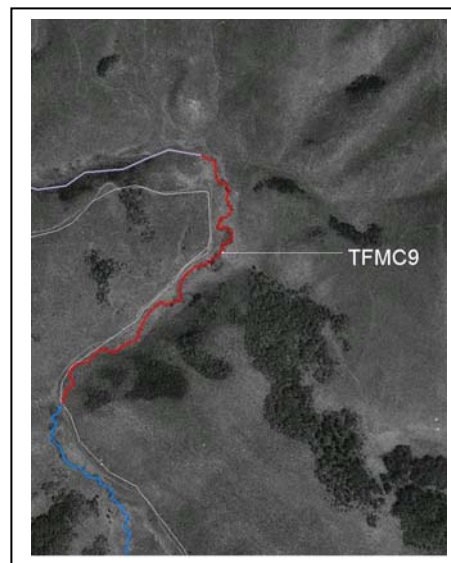
Reach	TFMC9
Length (ft)	2,706
Elevation (ft)	6,076
Stream Order	2 <sup>nd</sup>
Slope (%)	5.6
Sinuosity	1.2
Drainage Area (miles <sup>2</sup> )	10
SVAP	Poor
PFC	FAR
SECI	Moderate
Erosion (t/yr)	39

The reach had infrequent flooding events above bankfull and the stream channel was vertically unstable. The reach was found to have erosion and cracking present on streambanks.

Predominantly perennial/rock covered streambanks with severe vegetative overhang. V-shaped channel with vertical banks about 1 foot high. Channel bottom in gravels and cobbles with headcuts and evidence of recent deposition.

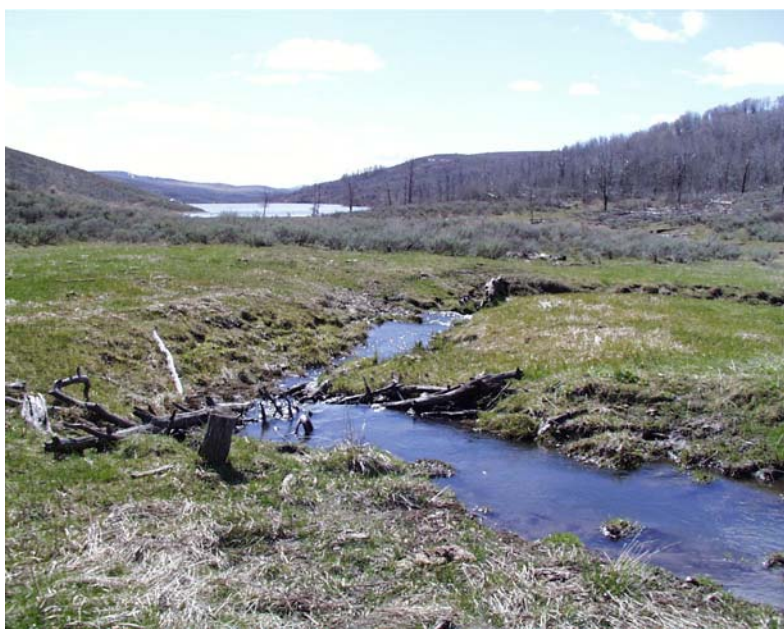
Reach	TFMC10
Length (ft)	2,411
Elevation (ft)	5,928
Stream Order	3 <sup>rd</sup>
Slope (%)	1.0
Sinuosity	1.2
Drainage Area (miles <sup>2</sup> )	10
SVAP	Poor
PFC	FAR
SECI	Moderate
Erosion (t/yr)	48

This photo of TFMC10 was taken in April 2000 and is looking downstream towards Twentyfourmile Reservoir.

Six to eight breached inactive beaver dams with headcuts comprised the reach. Riparian vegetation extended at least one channel width. Streambanks were slightly to moderately unstable. Sedges and rushes with few woody species present. Twenty to fifty percent of the water surface was shaded. Livestock access to the riparian area was noted. The reach had low sinuosity with high width/depth ratio, inadequate sources of coarse woody debris and was vertically unstable. The reach was found to have erosion and cracking on streambanks. Annuals/perennials covered streambanks with moderate vegetative overhang. U-shaped channel with vertical banks about 1 foot high. Channel bottom in silts and gravels with active downcutting and evidence of recent deposition.

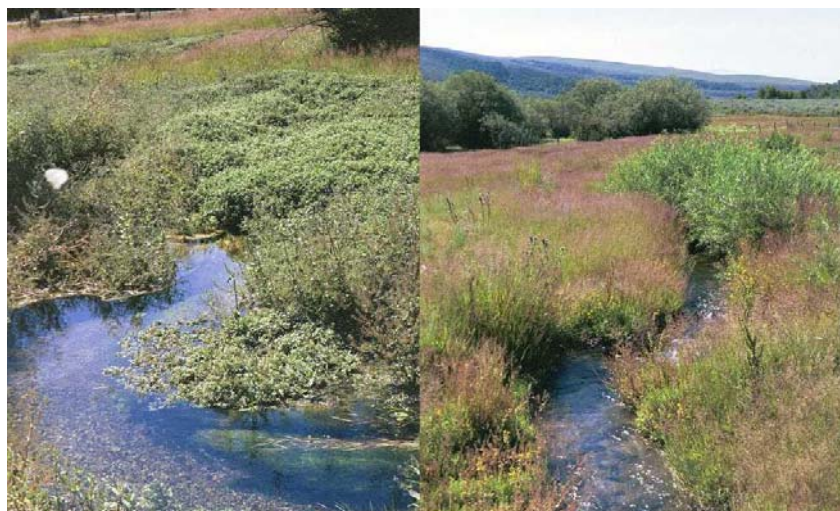
Reach	TFMC13
Length (ft)	879
Elevation (ft)	5,803
Stream Order	3 <sup>rd</sup>
Slope (%)	2.6
Sinuosity	1.4
Drainage Area (miles <sup>2</sup> )	20
SVAP	Good
PFC	PFC
SECI	Slight
Erosion (t/yr)	3.4

TFMC13 photos were taken facing downstream. The left one is in the middle of the reach. The right photo was on the upper end. This reach was the best of the stream reaches assessed on the creek.

The stream channel has moderate sinuosity with low width to depth ratios. Riparian vegetation extended at least two active channel widths on each side. Streambanks were stable. Sedges, rushes and willows were present. Water appearance was very clear with pools at least 3 feet deep present. No barriers to fish movement were present. Less than 20% of the water surface was shaded. Evidence of livestock access to the riparian area was noted. The reach was inundated in relatively frequent events, moderate sinuosity and low width/depth ratio, diverse age-class and composition of riparian/wetland plants. There was adequate cover on streambanks to dissipate energy and the stream channel is vertically stable. The reach does not appear to eroding. U-shaped channel, meandering channel with undercut banks about 1.0 foot high. Channel bottom in gravels and cobbles with evidence of recent deposition.

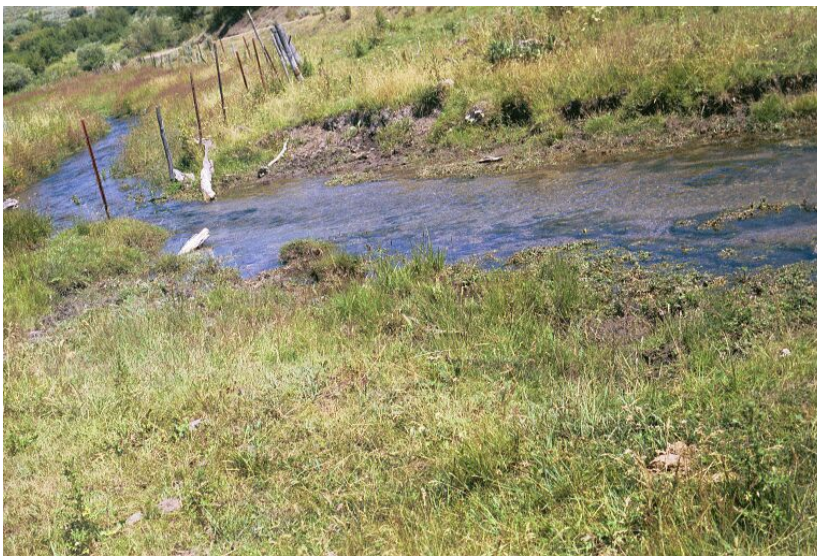
Reach	TFMC14
Length (ft)	904
Elevation (ft)	5,780
Stream Order	3 <sup>rd</sup>
Slope (%)	1.0
Sinuosity	1.1
Drainage Area (miles <sup>2</sup> )	20
SVAP	Fair
PFC	FAR
SECI	Moderate
Erosion (t/yr)	9.2

The TFMC14 photo is looking upstream towards TFMC13. The photo is skewed but note the vegetation contrast at the fence.

The stream channel has low to moderate sinuosity with high width to depth ratios. Riparian vegetation extended at least one active channel width on each

side. Streambanks were moderately stable. Sedges, rushes and willows were present but highly utilized. Willows were abundant on the west side of creek. Twenty to fifty percent of the water surface was shaded. Occasional manure in stream was noted. The reach had high width/depth ratio, low sinuosity, and inadequate vegetation cover on banks to protect during high flows and vegetation composition is present but highly utilized. Erosion and cracking was present on the predominantly perennial covered streambanks with moderate vegetative overhang. U-shaped channel with vertical banks about 1.0 foot high. Channel bottom in gravels and cobbles with evidence of recent deposition.

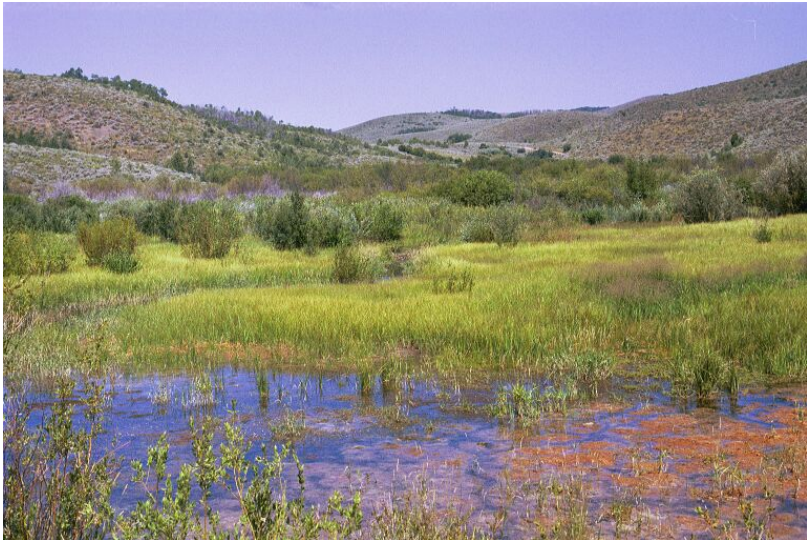
Reach	TFMC15
Length (ft)	1,368
Elevation (ft)	5,771
Stream Order	3 <sup>rd</sup>
Slope (%)	0.8
Sinuosity	1.2
Drainage Area (miles <sup>2</sup> )	20
SVAP	
PFC	
SECI	
Erosion (t/yr)

The photo of TFMC15 was taken from the man-made dam looking upstream. The stream flowed from the upper right to the lower left.

This reach was not rated using SVAP, PFC or SECI. However the picture below shows the end of this reach where a beaver dam was located near an old breached man-made earthen dam structure. The beaver dam was active but was not stable.

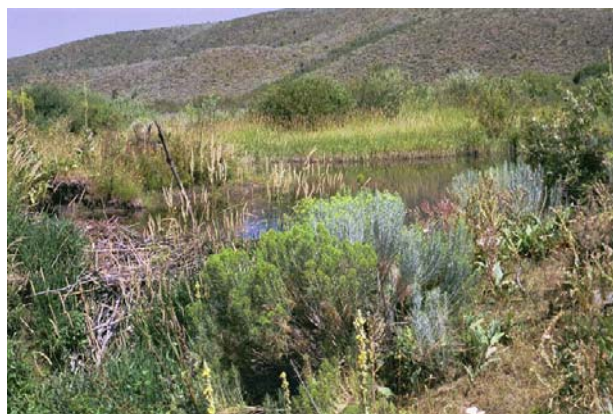
The photo of TFMC15 was taken just below the man-made dam looking upstream. A beaver dam was constructed in the breached earthen dam

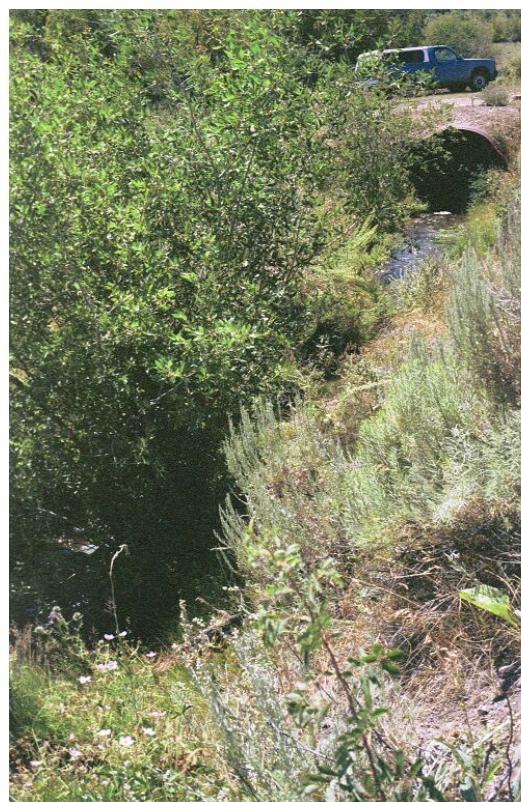
Reach	TFMC16
Length (ft)	706
Elevation (ft)	5,760
Stream Order	3 <sup>rd</sup>
Slope (%)	2.8
Sinuosity	1.1
Drainage Area (miles <sup>2</sup> )	20
SVAP	Poor
PFC	N
SECI	Moderate
Erosion (t/yr)	51

The stream channel is channelized and incised in this reach. Riparian vegetation extended at most one-third of the active channel width on each side. Streambanks were unstable. Some sedges and rushes were present but minimal. Few willows were present. Less than 20% of the water surface was shaded. Evidence of livestock access to the riparian area was noted. The reach was not inundated in relatively frequent events and beaver dams were unstable. Riparian vegetation lacked diverse age classes and composition. Streambank vegetation was inadequate to withstand high flow events. There were inadequate sources of woody debris and the stream channel is vertically unstable. Erosion and cracking were present on predominantly bare or annual covered streambanks with moderate vegetative overhang. Steep V-shaped channel with near vertical banks about 5 feet high. Channel bottom in gravels and cobbles with downcutting and no evidence of recent deposition.

The photo of TFMC16 was taken facing downstream. The road & culvert at the top of the photo is Twentyfourmile Road.

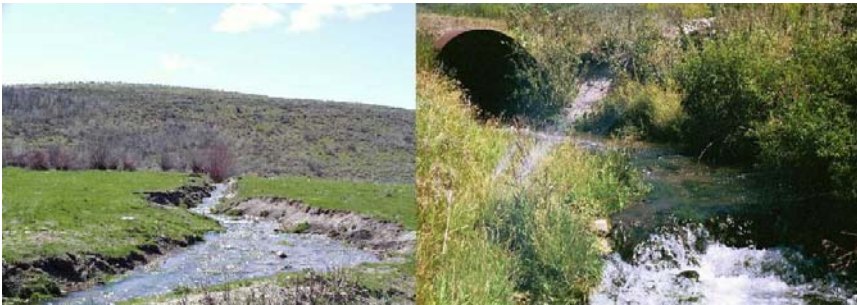
Reach	TFMC17
Length (ft)	709
Elevation (ft)	5,740
Stream Order	3 <sup>rd</sup>
Slope (%)	5.6
Sinuosity	1.0
Drainage Area (miles <sup>2</sup> )	20
SVAP	Poor
PFC	N
SECI	Severe
Erosion (t/yr)	115

The TFMC17 photo on the left was taken in May 2000 of the reach looking downstream and the photo on the right was taken in July 2000 looking upstream to the culvert on Twentyfourmile Road.

The stream channel is channelized and incised in this reach. Riparian vegetation extended at most one-third of the active channel width on each side. Streambanks were unstable. Some sedges, rushes and willows were present but minimal. Less than 20% of the water surface was shaded. Occasional to extensive amount of manure in the riparian area was noted. The reach was not inundated in relatively frequent events and beaver dams were unstable. Riparian vegetation lacked diverse age classes and composition. Streambank vegetation was inadequate to withstand high flow events. There were inadequate sources of woody debris and the stream channel is vertically unstable. Slumps and clumps were sloughing off into stream. Bare, rills and gullies on streambanks with severe vegetative overhang. Steep V-shaped channel with near vertical banks about 4 feet high. Channel bottom in gravels and cobbles with downcutting and no evidence of recent deposition.

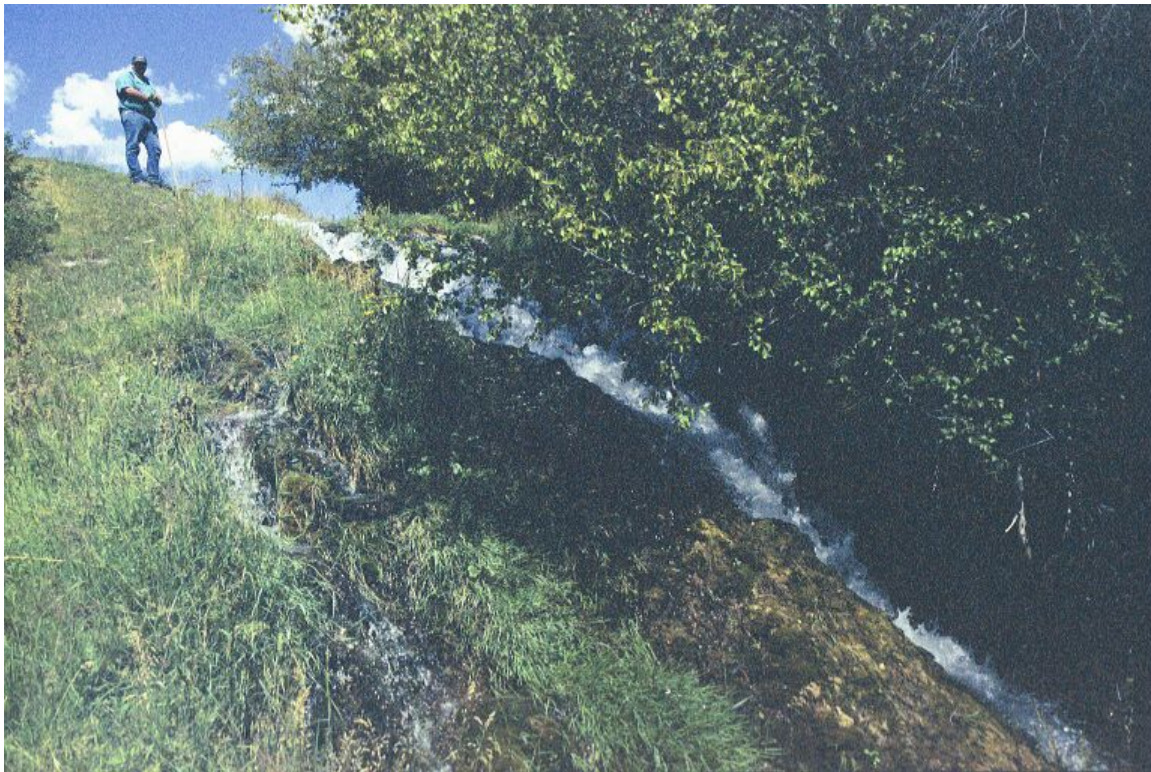
Reach	TFMC18
Length (ft)	100
Elevation (ft)	5,700
Stream Order	3 <sup>rd</sup>
Slope (%)	20
Sinuosity	1.0
Drainage Area (miles <sup>2</sup> )	20
SVAP	
PFC	
SECI	
Erosion (t/yr)

This photo was taken looking upstream on Reach TFMC18. Just below this cascade was a large (15 to 20 feet) head cut.

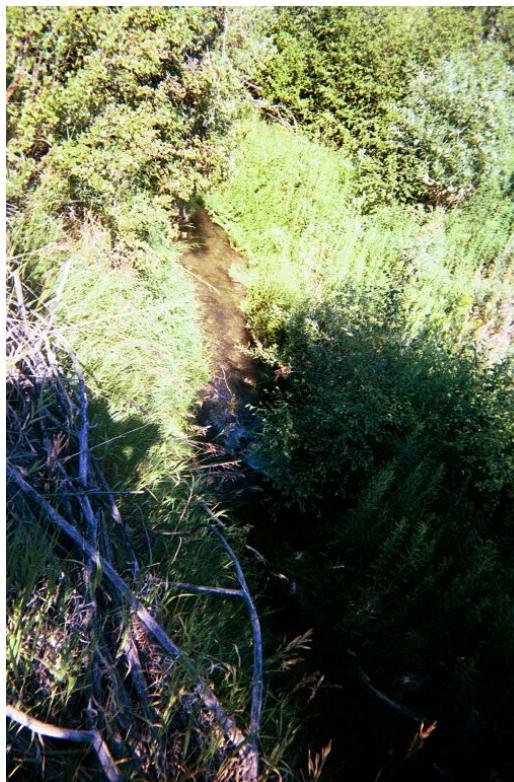
Reach	TFMC19
Length (ft)	3,793
Elevation (ft)	5,680
Stream Order	3 <sup>rd</sup>
Slope (%)	2.6
Sinuosity	1.3
Drainage Area (miles <sup>2</sup> )	22.5
SVAP	Poor
PFC	FAR
SECI	Severe
Erosion (t/yr)	1,245

The stream channel is deeply incised in this reach. Riparian vegetation extends at least one-half of the active channel width on each side. Streambanks were unstable. Some sedges and Rushes were present however woody species (including willows, alders, dogwood and birch) were abundant. Greater than 75% of the water surface was shaded. Occasional manure in the riparian area was noted. The reach was not inundated in relatively frequent events. Streambank vegetation and coverage was not capable of withstanding high flow events. The stream channel is vertically unstable. Slumps and clumps were sloughing off into stream. Bare, rills and gullies with annuals and perennials on streambanks with severe vegetative overhang. Steep V-shaped channel with near vertical banks about 15 feet high. Channel bottom in gravels and cobbles with downcutting and no evidence of recent deposition.

The TFMC19 photo was taken looking downstream.

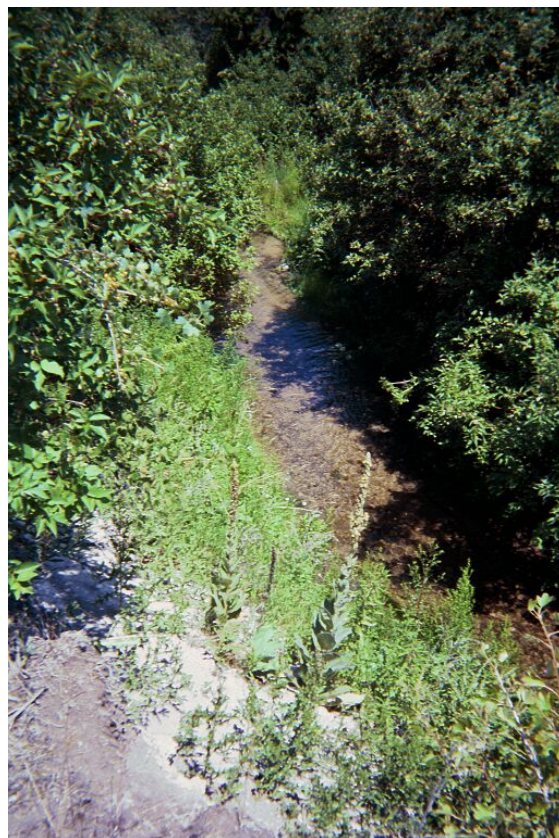
Reach	TFMC20
Length (ft)	3,050
Elevation (ft)	5,583
Stream Order	3 <sup>rd</sup>
Slope (%)	3.6
Sinuosity	1.2
Drainage Area (miles <sup>2</sup> )	22.5
SVAP	Poor
PFC	FAR
SECI	Moderate
Erosion (t/yr)	605

area was noted. Slumps and clumps sloughing off into stream. Bare, rills and gullies with annuals and perennials on banks with severe vegetative overhang. U-shaped channel with vertical banks about 15 feet high. Channel bottom in gravels and cobbles with active downcutting and evidence of recent deposition.

The TFMC20 photo was taken facing upstream in July 2000.

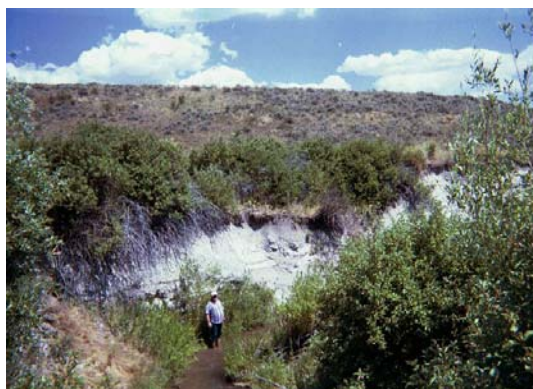
This photo of TFMC21 was taken facing downstream. This is representative of the downcutting that occurred in reaches TFMC19, TFMC20 & TFMC21 in the spring of 1985.

- 1) Riparian Forest Buffer (391A)
  - With Fencing (382), Buffer Strip (307), Use Exclusion (472)
  - With Streambank Protection (580), Stream Channel Stabilization (584), Channel Vegetation (322), Critical Area Planting (342)
  - With Structure for Water Control (587), Irrigation Water Conveyance (430)
  - Waste Management System (312), Waste Storage Facility (313)
- 2) Prescribed Grazing (528A)
  - With Spring Development (574), Brush Management (314), Water Well (642), Fencing (382), Trough/Tank (614), Pipeline (516), Use Exclusion (472)
  - With Streambank Protection (580), Stream Channel Stabilization (584), Channel Vegetation (322), Critical Area Planting (342)
  - With Structure for Water Control (587), Irrigation Water Conveyance (430)
  - Waste Management System (312), Waste Storage Facility (313)

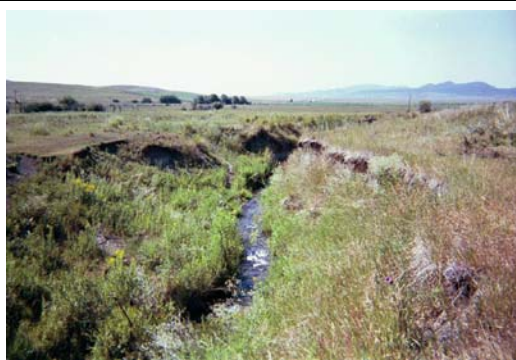
TFMC21 photo is looking downstream on the lower reach.

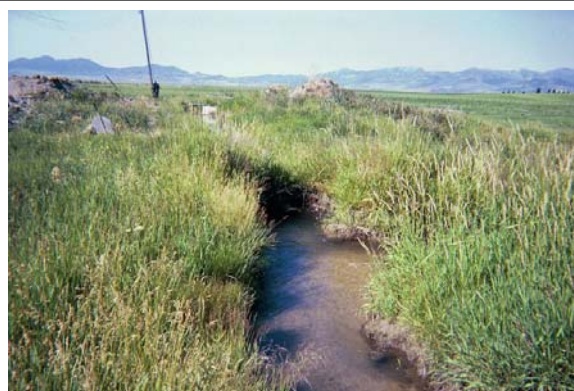
Reach	TFMC22
Length (ft)	3,421
Elevation (ft)	5,383
Stream Order	3 <sup>rd</sup>
Slope (%)	0.8
Sinuosity	1.2
Drainage Area (miles <sup>2</sup> )	23
SVAP	Poor
PFC	FAR
SECI	Severe
Erosion (t/yr)	76

Riparian vegetation extends at least one-half active channel width on each side. Streambanks were moderately unstable. Less than 20% of the water surface was shaded. Livestock access to the riparian area was noted. The riparian vegetation reach had no diverse age-classes and incapable of withstanding high flow events with inadequate source of woody debris. Stream channel is vertically unstable. Erosion is evident with perennials covered streambanks with moderate vegetative overhang. U-shaped channel, meandering channel with undercut banks about 2 foot high. Channel bottom in gravels with evidence of active downcutting and recent deposition.

TFMC22 photo was taken looking downstream on the upper end of the reach. In the middle of the picture the stream splits into two channels. The left channel flows into an irrigation pump system.

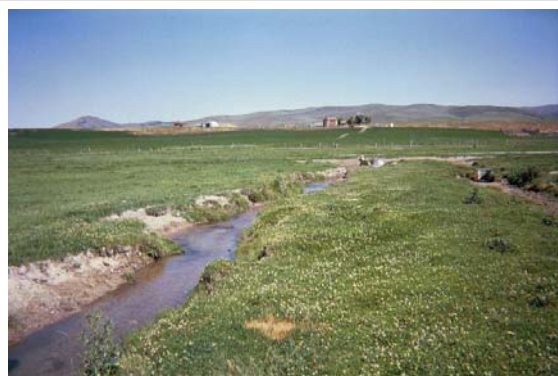
This photo of TFMC22 was taken facing upstream from the lower end of the reach.

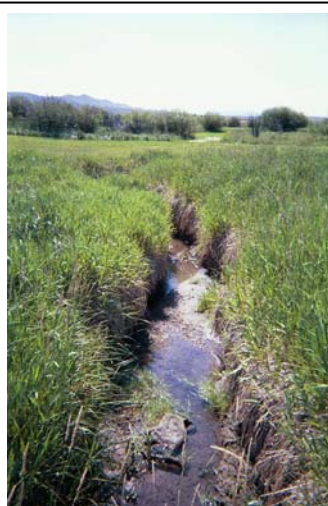
of livestock access to the riparian area was noted. There were unstable beaver dams. The reach had low sinuosity, few willows and is vertically unstable. Does not appear to be eroding. Predominantly perennials covering streambanks with slight vegetative overhang. U-shaped channel, meandering channel with undercut banks about 2 foot high. Channel bottom in gravels and cobbles and evidence of recent deposition.

The TFMC23 photo was taken facing downstream just below the irrigation diversion at the start of the reach.

- 1) Riparian Forest Buffer (391A)
  - With Fencing (382), Buffer Strip (307), Use Exclusion (472)
  - With Streambank Protection (580), Stream Channel Stabilization (584), Channel Vegetation (322),
  - With Structure for Water Control (587), Irrigation Water Conveyance (430), Irrigation Water Management (449)
- 2) Prescribed Grazing (528A)
  - With Water Well (642), Fencing (382), Trough/Tank (614), Pipeline (516), Use Exclusion (472)
  - With Streambank Protection (580), Stream Channel Stabilization (584), Channel Vegetation (322),
  - With Structure for Water Control (587), Irrigation Water Conveyance (430), Irrigation Water Management (449)

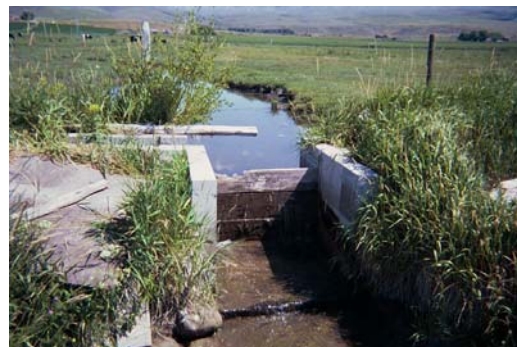
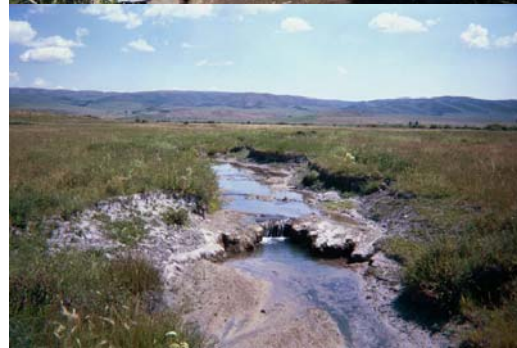
TMFC23 photos: Irrigation diversion structure (top) and headcut (bottom).

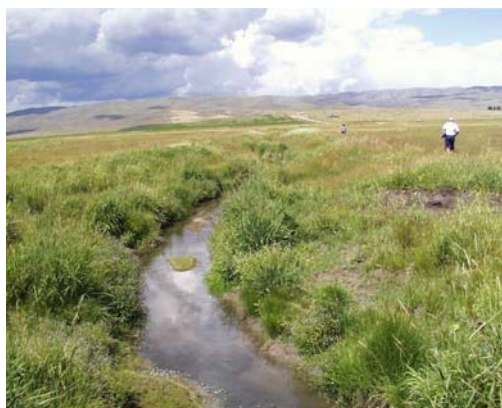
The creek is channelized and incised in this reach. Riparian vegetation extends at most one-third of active channel width. Streambanks were moderately unstable. Less than 20% of the water surface is shaded. Riffles are completely embedded. Evidence of livestock access to the riparian area was noted.

The reach was not inundated in relatively frequent events. The floodplain and channel are inadequate to dissipate energy and point bars are not revegetating. Stream movement is not associated with natural sinuosity and stream channel is vertically unstable. Erosion and cracking present. Predominantly perennials covering streambanks with moderate vegetative overhang. U-shaped channel with vertical banks about 4 feet high. Channel bottom in gravels and cobbles with downcutting and evidence of recent deposition.

This TFMC24 reach photo was taken looking upstream from the middle of the reach.

- 1) Riparian Forest Buffer (391A) or Riparian Herbaceous Buffer (390)
  - With Fencing (382), Buffer Strip (307), Use Exclusion (472)
  - With Streambank Protection (580), Stream Channel Stabilization (584), Channel Vegetation (322)
- 2) Prescribed Grazing (528A)
  - With Water Well (642), Spring Development (574), Fencing (382), Trough/Tank (614), Pipeline (516), Use Exclusion (472)
  - With Streambank Protection (580), Stream Channel Stabilization (584), Channel Vegetation (322)

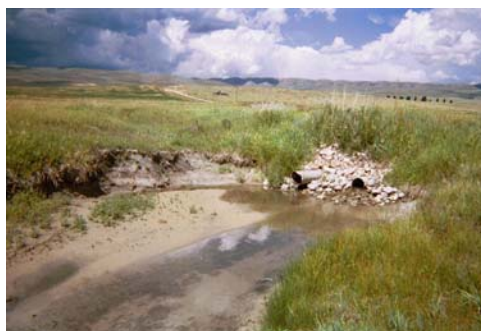
This upstream photo of a stream crossing for a field road is located in the middle of reach TFMC24.

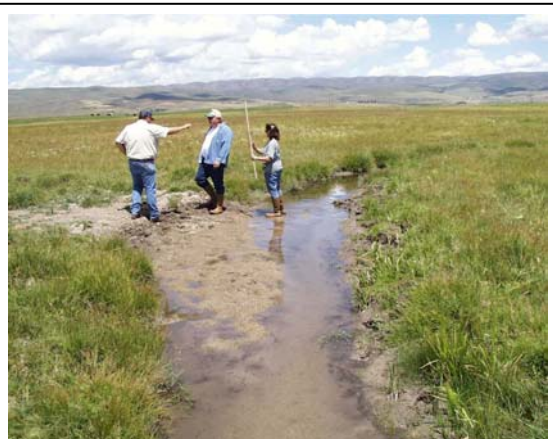
Riparian vegetation extends at most one-half of active channel width on each side. Streambanks were moderately stable. Less than 20% of the water surface was shaded. Riffle is completely embedded. Evidence of livestock access to the riparian area was noted.

The reach had low sinuosity with no diverse age-classes and low vigor. There was no source of woody debris and stream movement is not associated with natural sinuosity. Erosion is evident. Predominantly perennials covering streambanks with slight vegetative overhang. U-shaped channel with vertical banks about 1 foot high. Channel bottom in gravels and cobbles and evidence of recent deposition.

The TFMC25 photo was taken on the lower end of the reach facing upstream.

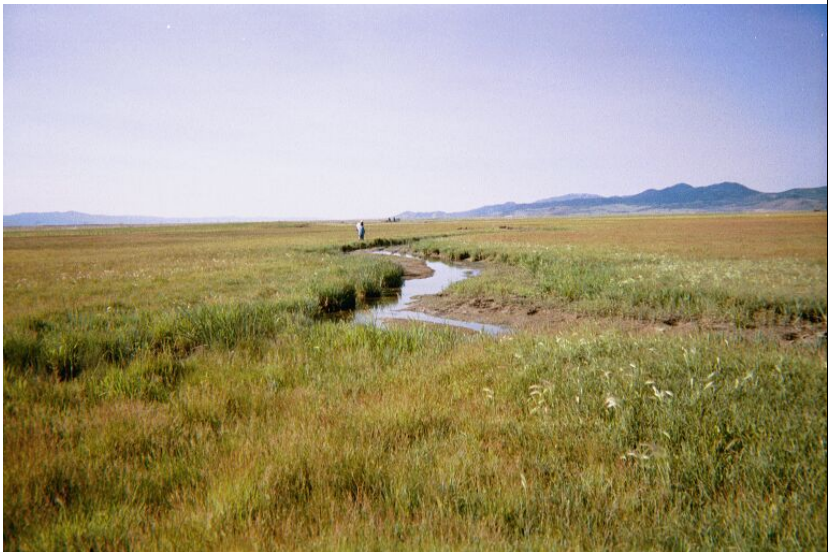
Reach	TFMC26
Length (ft)	3,953
Elevation (ft)	5,324
Stream Order	3 <sup>rd</sup>
Slope (%)	0.3
Sinuosity	1.2
Drainage Area (miles <sup>2</sup> )	26.7
SVAP	Poor
PFC	FAR
SECI	Moderate
Erosion (t/yr)	26

This photo of TFMC26 was taken on the upper end of the reach facing downstream.

Evidence of livestock access to the riparian area was noted. The reach was low sinuosity and no source of woody debris. Erosion is evident. Predominantly perennials covering streambanks with slight vegetative overhang. U-shaped channel with vertical banks about 1 foot high. Channel bottom in silt, sand and gravels with active downcutting and evidence of recent deposition.

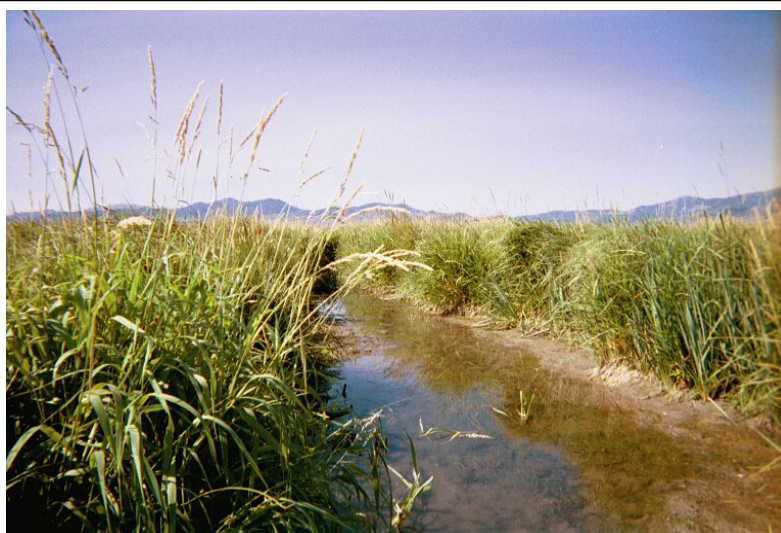
Reach	TFMC27
Length (ft)	1,467
Elevation (ft)	5,314
Stream Order	3 <sup>rd</sup>
Slope (%)	0.01
Sinuosity	1.1
Drainage Area (miles <sup>2</sup> )	26.7
SVAP	Fair
PFC	FAR
SECI	Moderate
Erosion (t/yr)	10

The TFMC27 photo was taken facing downstream on the upper end. Sedge and Rush were 2 to 3 feet tall within this reach.

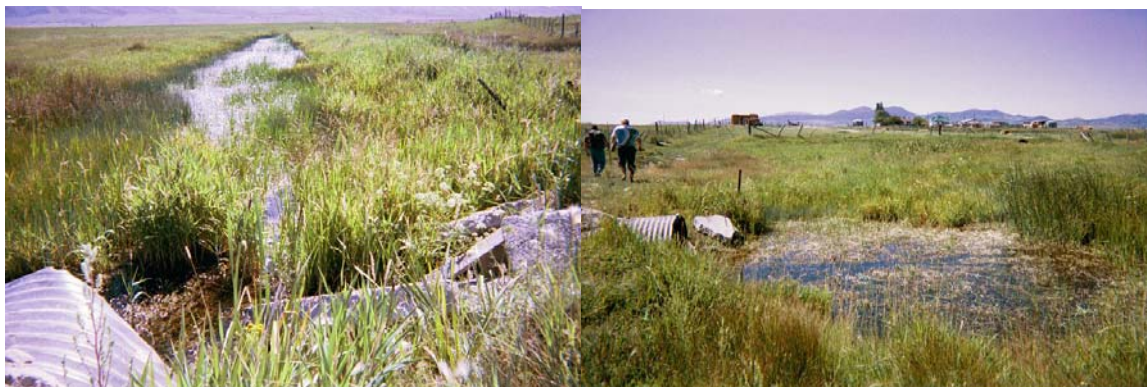
The photo on the left is reach TFMC28 facing upstream just before the creek enters the old Portneuf River channel shown in the right photo.

Riparian vegetation extends at most one-third of the active channel width on each side. Streambanks were slightly stable. Less than 20% of the water surface was shaded. Macroinvertebrates were dominated by facultative species. Riffles are completely embedded. The reach was not inundated in relatively frequent events. Sinuosity and gradient are not in balance with landscape setting. Riparian vegetation lacked diverse age-class distribution and is inadequate to protect banks. Does not appear to be eroding. Predominantly perennials covering streambanks with slight vegetative overhang. U-shaped channel with vertical banks about 3 feet high. Channel bottom in silt and sand with evidence of recent deposition.

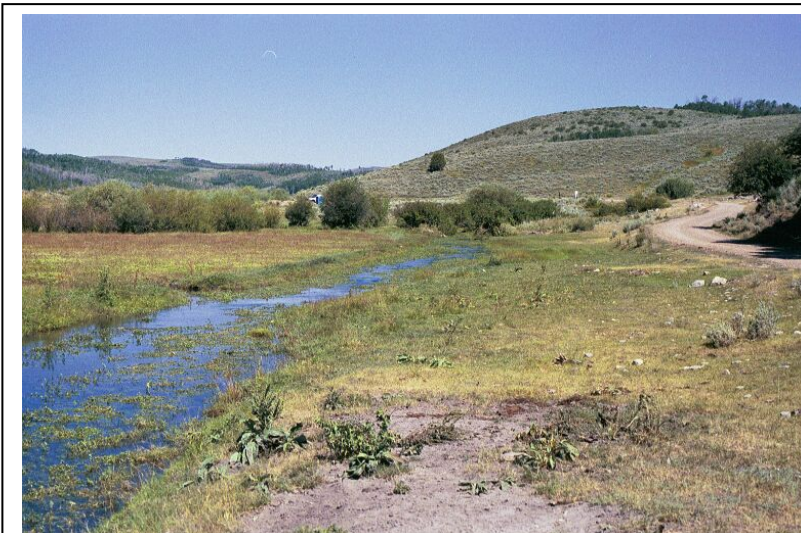
Reach	EF3
Length (ft)	1,609
Elevation (ft)	5,904
Stream Order	1 <sup>st</sup>
Slope (%)	0.2
Sinuosity	1.1
Drainage Area (miles <sup>2</sup> )	10
SVAP	Poor
PFC	FAR
SECI	Severe
Erosion (t/yr)	53

This photo of EF3 was taken in July 2000 and is looking upstream. To the right of the creek is Twentyfourmile Road.

The stream channel is braided and then channelized. Riparian vegetation extended only one-half of the active channel width. Streambanks were moderately unstable. Sedges and rushes with few willows were present in the upper section of reach. Less than 20% of the water surface was shaded. Evidence of livestock access to the riparian area was noted. The reach had low sinuosity with high width/depth ratio, insufficient vegetative cover to protect streambanks, inadequate source of coarse/large woody material, insufficient soil moisture characteristics, low vigor riparian plants and excessive streambank trampling. The reach was found to have slumps and clumps sloughing into the stream. Streambanks were covered with annuals or about 70% bare with moderate vegetative overhang. U-shaped channel with vertical banks about 1 foot high. Channel bottom in gravels and cobbles with evidence of recent deposition.

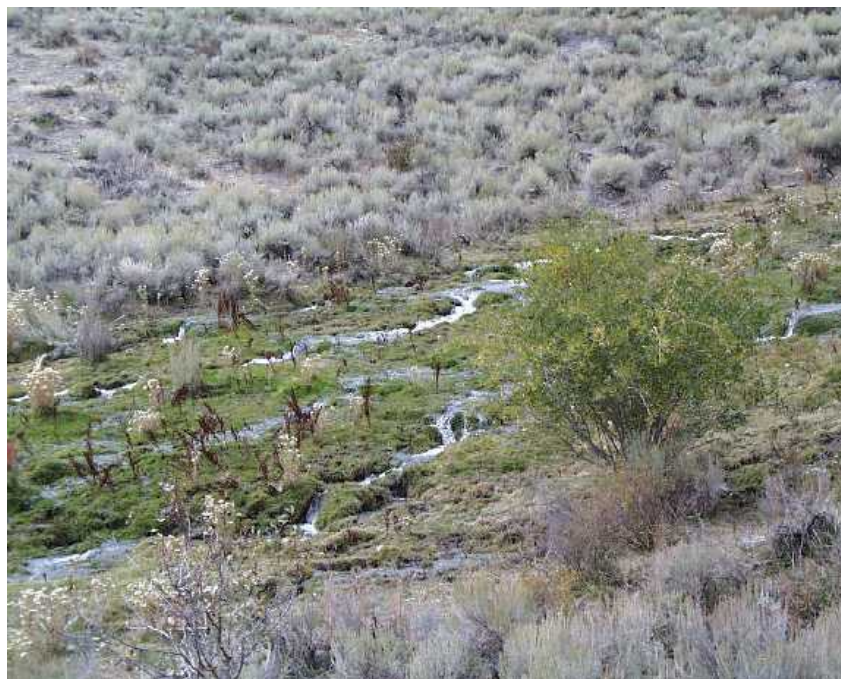
Reach	EF4
Length (ft)	460
Elevation (ft)	5,900
Stream Order	1 <sup>st</sup>
Slope (%)	11.1
Sinuosity	1.0
Drainage Area (miles <sup>2</sup> )	10
SVAP	Poor
PFC	FAR
SECI	Slight
Erosion (t/yr)	0.3

The photo of EF4 was taken in April 2000 and looking west from Twentyfourmile Road.

to the riparian area was noted. The reach had high width/depth ratio and inadequate source of coarse/large woody material.

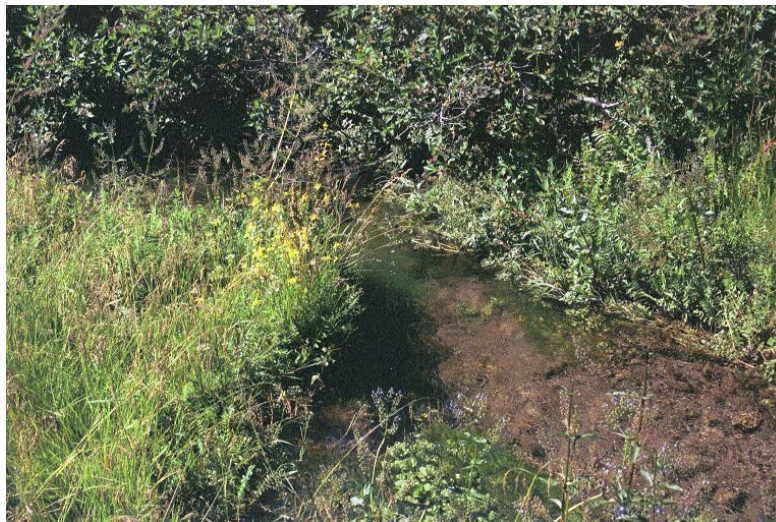
EF5 reach photo was taken looking downstream in July 2000. This reach was next to the best of the stream reaches assessed.

The stream channel has moderate sinuosity with a head cut at the lower end of the reach. Riparian vegetation
